# Access Compliance Report Public Rights-of-Way (Curb Ramps)

Main Street: **CHIRPING\_SPARROW\_WAY** Cross Street: **BLUEBERRY\_WAY** Location: **SE**

ADA ID: **RPAT211008123251** Ramp Type: **Type 4 - Parallel** Initial Pass/Fail: **Pass** Overall Compliance: **No** Severity Score: **0**

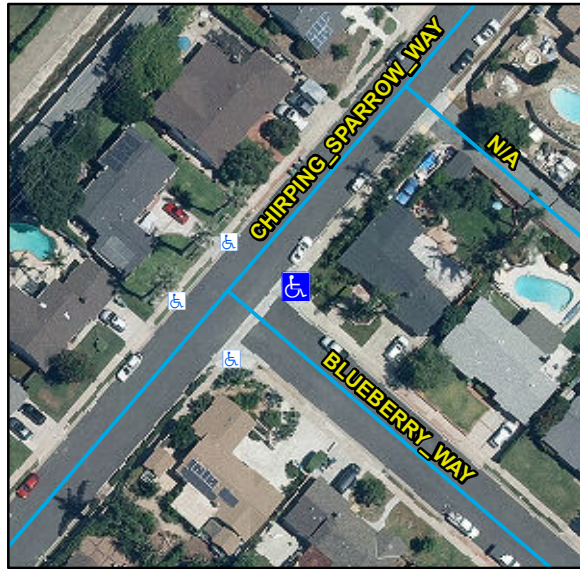
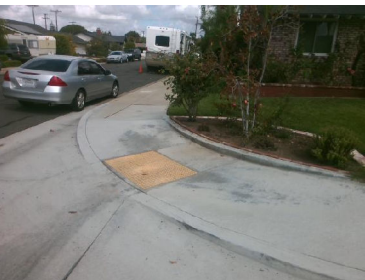
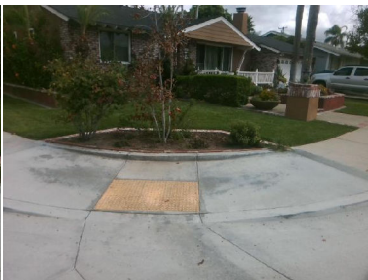
| Compliance | Description | Data | Compliance | Description | Data |
|---|---|---|---|---|---|
| <b>Yes</b> | Gutter Ponding | <b>No</b> | <b>No</b> | Curb Slope | <b>9.4</b> |

**Remove & Replace Curb Slope.**

**R304.2.2, STD 1115**
