# Access Compliance Report Public Rights-of-Way (Curb Ramps)

| Main Street: BLUEBERRY_WAY | | Cross Street: CHIRPING_SPARROW_WAY | | Location: | SW |
| ADA ID: RPAT211008123720 | Ramp Type: Type 4 - Parallel | Initial Pass/Fail: Fail | Overall Compliance: No | Severity Score: | 2 |

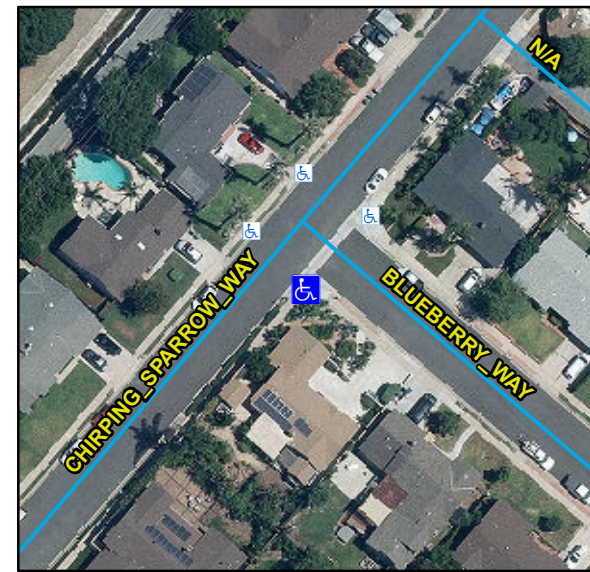
| Compliance | Description | Data | Compliance | Description | Data |
|---|---|---|---|---|---|
| Yes | Ramp Cross Slope LT (%) | 0.4 | No | Ramp Cross Slope RT (%) | 3.3 |
| N/A | Gutter Ponding | N/A | No | Curb Slope | 10.6 |

**Remove & Replace Curb Ramp With Two New Directional Ramps or Equivalent.**

**R304.2.2, R304.5.3, STD 1115**

Total Cost: \$ 4000
