# Access Compliance Report Public Rights-of-Way (Curb Ramps)

Main Street: CHIRPING\_SPARROW\_WAY Cross Street: ROLLINGSTONE\_LN Location: SE

ADA ID: RPAT211008124204 Ramp Type: Type 4 - Parallel Initial Pass/Fail: Fail Overall Compliance: No Severity Score: 2

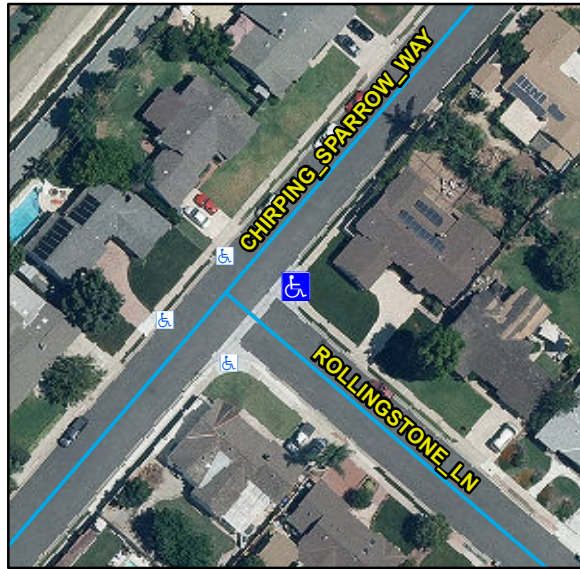
| Compliance | Description | Data | Compliance | Description | Data |
|---|---|---|---|---|---|
| No | Ramp Cross Slope LT (%) | 3.3 | No | Ramp Cross Slope RT (%) | 3.4 |

**Remove & Replace Curb Ramp With Two New Directional Ramps or Equivalent.**

**R304.5.3, STD 1115**
