# Access Compliance Report Public Rights-of-Way (Curb Ramps)

Main Street: HICKORY\_BRANCH\_RD Cross Street: BENT\_TWIG\_LN Location: E

ADA ID: RPAT211008140642 Ramp Type: Type 1 - Perpendicular Diagonal Initial Pass/Fail: Pass Overall Compliance: No Severity Score: 2

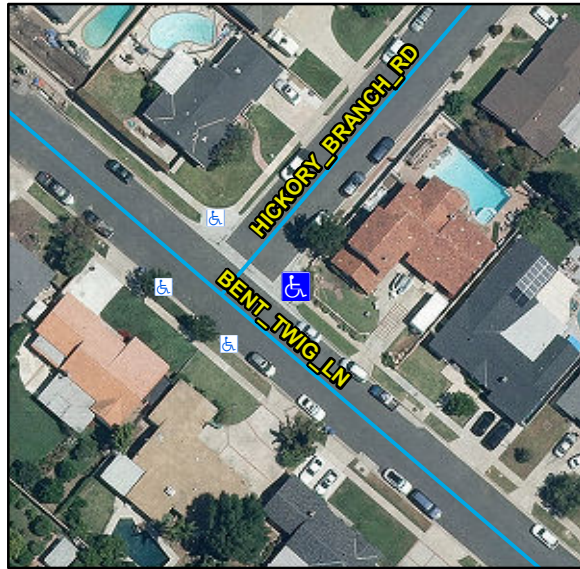
| Compliance | Description | Data | Compliance | Description | Data |
|---|---|---|---|---|---|
| Yes | Gutter Ponding | No | No | Curb Slope | 9.1 |

Remove & Replace Curb Ramp With Two New Directional Ramps or Equivalent.

R304.2.2, R304.2.1, STD 1115
