# Access Compliance Report Public Rights-of-Way (Curb Ramps)

Main Street: BENT\_TWIG\_LN Cross Street: HICKORY\_BRANCH\_RD Location: NE

ADA ID: RPAT211008141059 Ramp Type: Type 1 - Perpendicular Diagonal Initial Pass/Fail: Pass Overall Compliance: No Severity Score: 0

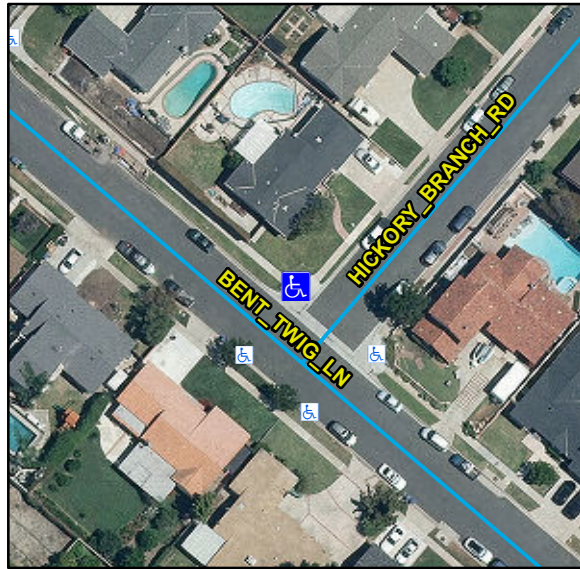
| Compliance | Description | Data | Compliance | Description | Data |
|---|---|---|---|---|---|
| No | Landing Run Slope (%) | 2.4 | N/A | Flare Traversable RT | No |
| Yes | Gutter Ponding | No | No | Curb Slope | 6.2 |

Remove & Replace Curb Ramp With Two New Directional Ramps or Equivalent.

R304.2.2, R304.2.2-Perp, R304.3.2-Para, STD 1115
