# Access Compliance Report Public Rights-of-Way (Curb Ramps)

Main Street: HICKORY\_BRANCH\_RD Cross Street: HICKORY\_BRANCH\_RD Location: SW

ADA ID: RPAT211008142919 Ramp Type: Type 4 - Parallel Initial Pass/Fail: Fail Overall Compliance: No Severity Score: 16

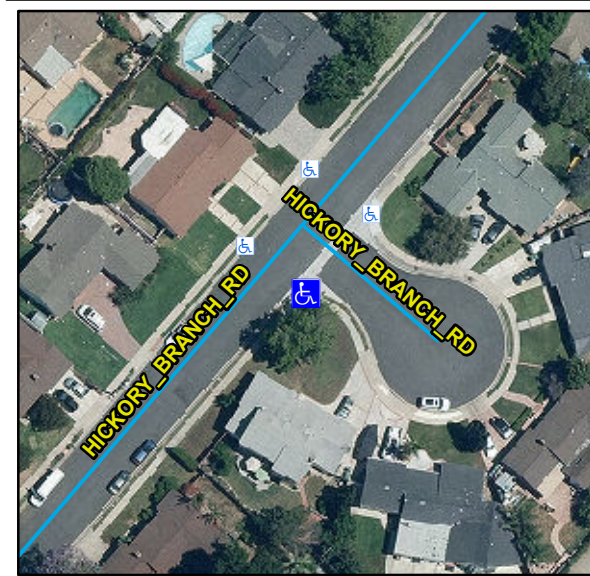
| Compliance | Description | Data | Compliance | Description | Data |
|---|---|---|---|---|---|
| No | Ramp Run Slope LT (%) | 8.6 | Yes | Ramp Run Slope RT (%) | 6.9 |
| Yes | Ramp Cross Slope LT (%) | 1.9 | No | Ramp Cross Slope RT (%) | 3.7 |

Possible Solutions:  
**Remove & Replace Curb Ramp With Two New Directional Ramps or Equivalent.**

OC Std/PROW:  
**R304.3.2, R304.5.3, STD 1115**
