# Access Compliance Report Public Rights-of-Way (Curb Ramps)

Main Street: HICKORY\_BRANCH\_RD Cross Street: HICKORY\_BRANCH\_RD Location: SE

ADA ID: RPAT211008143311 Ramp Type: Type 4 - Parallel Initial Pass/Fail: Fail Overall Compliance: No Severity Score: 2

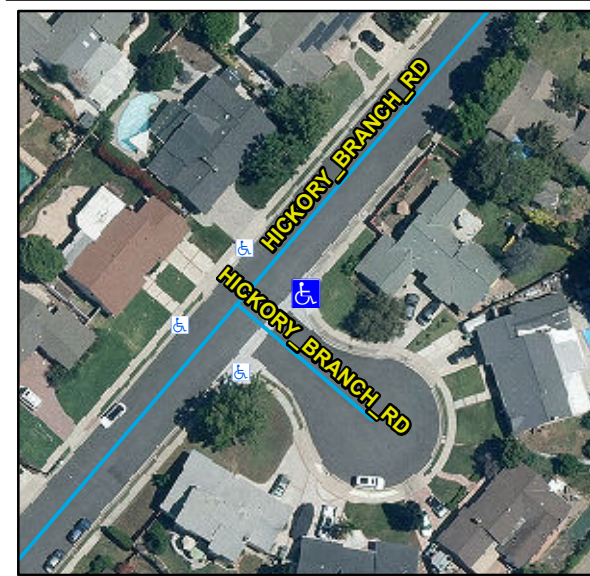
| Compliance | Description | Data | Compliance | Description | Data |
|---|---|---|---|---|---|
| No | Ramp Cross Slope LT (%) | 3.3 | No | Ramp Cross Slope RT (%) | 2.7 |

Remove & Replace Curb Ramp With Two New Directional Ramps or Equivalent.

R304.5.3, STD 1115

Total Cost: \$ 4000
