# Access Compliance Report Public Rights-of-Way (Curb Ramps)

Main Street: BLUEBERRY\_WAY Cross Street: HICKORY\_BRANCH\_RD Location: SW

ADA ID: RPAT211008145232 Ramp Type: Type 1 - Perpendicular Diagonal Initial Pass/Fail: Fail Overall Compliance: No Severity Score: 16

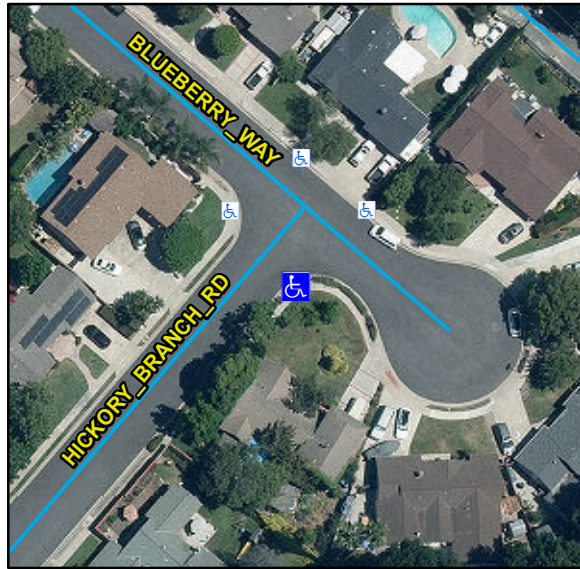
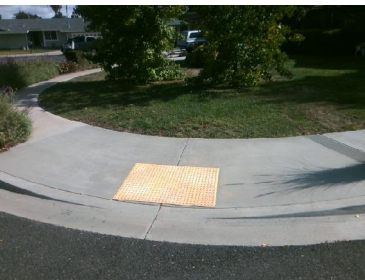
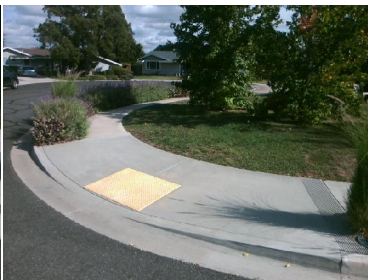
| Compliance | Description | Data | Compliance | Description | Data |
|---|---|---|---|---|---|
| No | Ramp Run Slope (%) | 8.7 | N/A | Flare Slope LT (%) | N/A |
| No | Ramp Cross Slope (%) | 4.3 | N/A | Flare Traversable LT | N/A |

Remove & Replace Curb Ramp With Two New Directional Ramps or Equivalent.
