# Access Compliance Report Public Rights-of-Way (Curb Ramps)

| Main Street: BRITTANY_WOODS_DR | Cross Street: BLUEBERRY_WAY | Location: | SE |

| ADA ID: RPAT211008150134 | Ramp Type: Type 4 - Parallel | Initial Pass/Fail: Fail | Overall Compliance: No | Severity Score: | 2 |

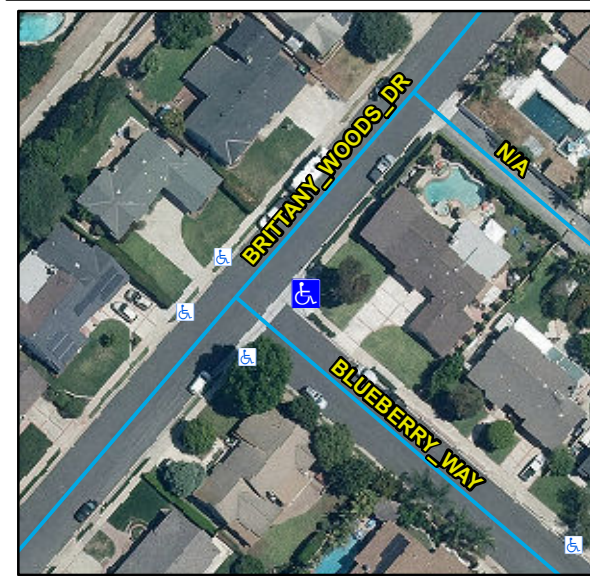
| Compliance | Description | Data | Compliance | Description | Data |
|---|---|---|---|---|---|
| No | Ramp Cross Slope LT (%) | 2.5 | No | Ramp Cross Slope RT (%) | 2.9 |

**Remove & Replace Curb Ramp With Two New Directional Ramps or Equivalent.**

**R304.5.3, STD 1115**
