# Access Compliance Report Public Rights-of-Way (Curb Ramps)

| Main Street: WOODLAWN_AVE | | Cross Street: CAMEO_DR | | Location: | NW |
| ADA ID: RPAT211011094756 | Ramp Type: Type 3 - Combination 1 | Initial Pass/Fail: Fail | Overall Compliance: No | Severity Score: | 15 |

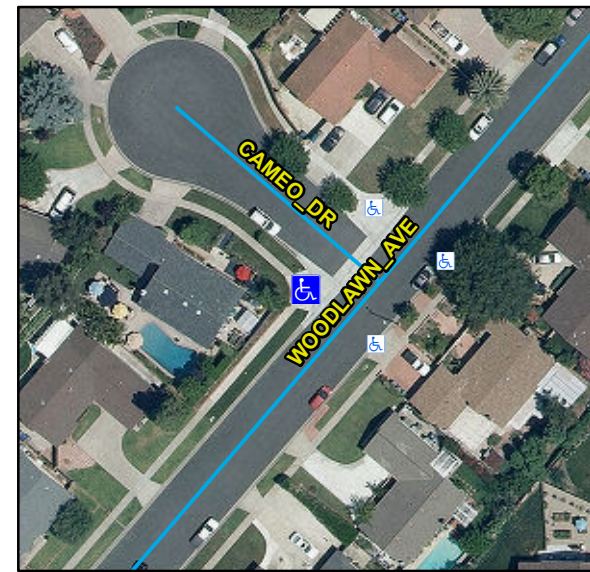
| Compliance | Description | Data | Compliance | Description | Data |
|---|---|---|---|---|---|
| Yes | Ramp Run Slope LT (%) | 4.9 | No | Ramp Run Slope RT (%) | 10.9 |
| No | Ramp Run Slope (%) | 10.5 | N/A | Flare Slope LT (%) | N/A |

**Remove & Replace Curb Ramp With Two New Directional Ramps or Equivalent.**

**R304.2.2, R304.3.2, STD 1115**

Total Cost: \$ 6160
