Access Compliance Report Public Rights-of-Way (Curb Ramps)

Main Street: CHARLOMA DR **Cross Street: LURLINE LN** NW Location:

Ramp Type: Type 1 - Perpendicular Diagonal Initial Pass/Fail: Pass ADA ID: RPAT211011100455

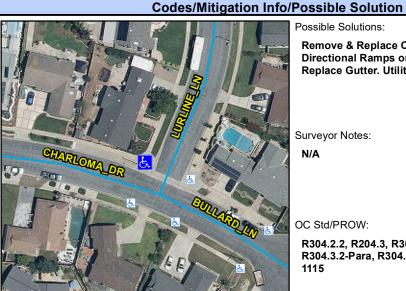
Overall Compliance: No Severity Score:

Field Measurements/Component Compliance								
-	Com	pliance Description	Data	Com	pliance Description	Data		
	N/A	Ramp Length (in)	132	N/A	Flare Type LT			
	Yes	Ramp Width (in)	52			Sloped		
	Yes	Ramp Run Slope (%)	6.3	N/A	Flare Slope LT (%)	8.1		
	Yes	Ramp Cross Slope (%)	1.8	N/A	Flare Traversable LT	No		
	N/A	Landing Present	No	N/A	Flare Type RT			
	N/A	Landing Length (in)	N/A			Sloped		
	No	Landing Width (in)	N/A	N/A	Flare Slope RT (%)	6.9		
	No	Landing Run Slope (%)	N/A	N/A	Flare Traversable RT	No		
	No	Landing Cross Slope (%)	N/A	No	DWS Provided	No		
	N/A	Landing Movement Obstructed?	Yes	N/A	DWS Contrast	N/A		
		Landing Movement Type	Wall	N/A	DWS Length (in)	N/A		
	N/A	Landing Shared	N/A	N/A	DWS Full Width	N/A		
	N/A	Clear Space	Yes	N/A	DWS Offset Left (in)	N/A		
	N/A	Clear Space To Crosswalk (in)	48	N/A	DWS Offset Right (in)	N/A		
2	N/A	Marked Crosswalk 1	No	N/A	Marked Crosswalk 2	No		
		Crossing 1 Direction	E		Crossing 2 Direction	S

١ ا		Marked Crosswalk 1 Width (in)	N/A		Marked Crosswalk 2 Width (in)	N/A		
ı	N/A	Ramp Inside Crosswalk 1	N/A	Yes	Ramp Inside Crosswalk 2	N/A		
ı		Crossing 1 Slope (%)	6		Crossing 2 Slope (%)	2.7		
ı		Crossing 1 Cross Slope (%)	2.9		Crossing 2 Cross Slope (%)	4.1		
	Yes	Gutter Ponding	No	No	Curb Slope	8.2		
	Yes	Gutter Lip Height (in)	0		Road Run Slope (%)	0.4		
	No	Gutter Run Slope (%)	6.1		Road Cross Slope (%)	4.7

-	Yes	Gutter Cross Slope (%)	0.7					
•	Yes Overall Surface Condition: Acceptable		No	Perp Joint Present	No			
		Cross Gutter Present?	Yes		Spandrel Present?	Yes		
'		Replace Cross Gutter?	No		Replace Spandrel?	No

Remove & Replace Curb Ramp With Two New Directional Ramps or Equivalent. Remove & Replace Gutter. Utility Present.
