# Access Compliance Report Public Rights-of-Way (Curb Ramps)

Main Street: LURLINE\_LN Cross Street: BULLARD\_LN Location: E

ADA ID: RPAT211011100845 Ramp Type: Type 1 - Perpendicular Diagonal Initial Pass/Fail: Pass Overall Compliance: No Severity Score: 22

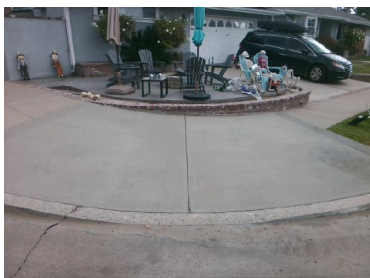
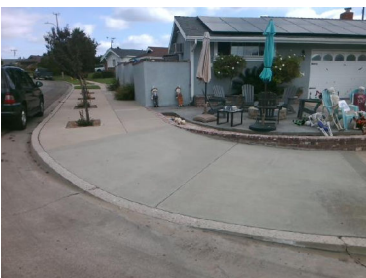
| Compliance | Description | Data | Compliance | Description | Data |
|---|---|---|---|---|---|
| Yes | Ramp Run Slope (%) | 7.8 | No | Flare Slope LT (%) | 10.8 |
| No | Landing Width (in) | N/A | Yes | Flare Slope RT (%) | 2 |
| No | Landing Cross Slope (%) | N/A | No | DWS Provided | No |
| Yes | Gutter Ponding | No | No | Curb Slope | 9.4 |
| No | Gutter Cross Slope (%) | 4.5 | | | |

Remove & Replace Curb Ramp With Two New Directional Ramps or Equivalent. Remove & Replace Gutter.
