# Access Compliance Report Public Rights-of-Way (Curb Ramps)

Main Street: WASS\_ST Cross Street: CHARLOMA\_DR Location: NE

ADA ID: RPAT211011101912 Ramp Type: Type 1 - Perpendicular Diagonal Initial Pass/Fail: Fail Overall Compliance: No Severity Score: 2

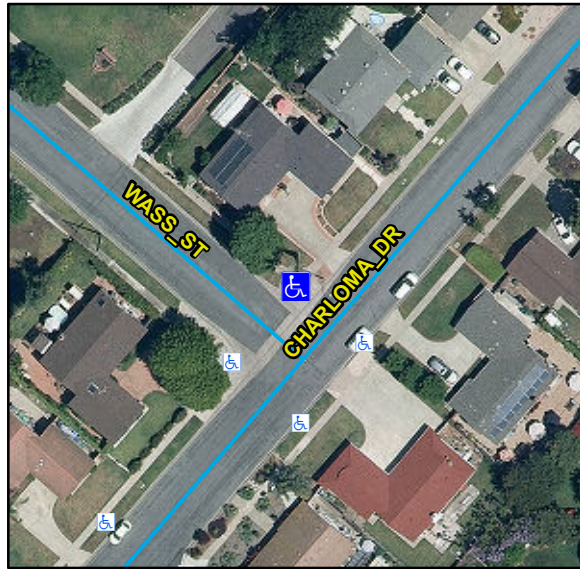
| Compliance | Description | Data | Compliance | Description | Data |
|---|---|---|---|---|---|
| No | Ramp Cross Slope (%) | 4.6 | N/A | Flare Traversable LT | N/A |

Remove & Replace Curb Ramp With Two New Directional Ramps or Equivalent.
