# Access Compliance Report Public Rights-of-Way (Curb Ramps)

Main Street: CHARLOMA\_DR Cross Street: WASS\_ST Location: NW

ADA ID: RPAT211011102408 Ramp Type: Type 1 - Perpendicular Diagonal Initial Pass/Fail: Fail Overall Compliance: No Severity Score: 30

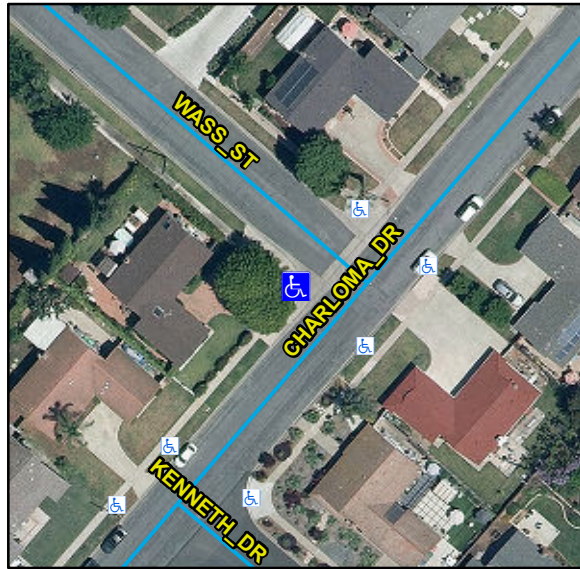
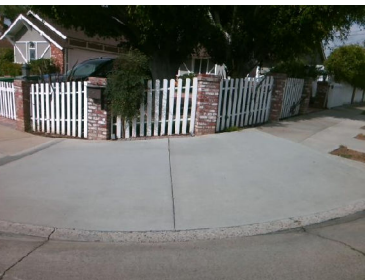
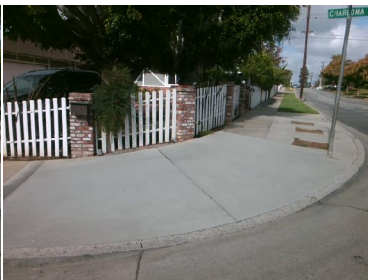
R304.2.2, R304.5.3, STD 1115

| Compliance | Description | Data | Compliance | Description | Data |
|---|---|---|---|---|---|
| No | Ramp Cross Slope (%) | 8.5 | N/A | Flare Traversable LT | N/A |

Remove & Replace Curb Ramp With Two New Directional Ramps or Equivalent.

Total Cost: \$ 6160
