# Access Compliance Report Public Rights-of-Way (Curb Ramps)

Main Street: ELIZABETH\_WY Cross Street: WINDSOR\_LN Location: W

ADA ID: RPAT211011110057 Ramp Type: Type 1 - Perpendicular Diagonal Initial Pass/Fail: Fail Overall Compliance: No Severity Score: 16

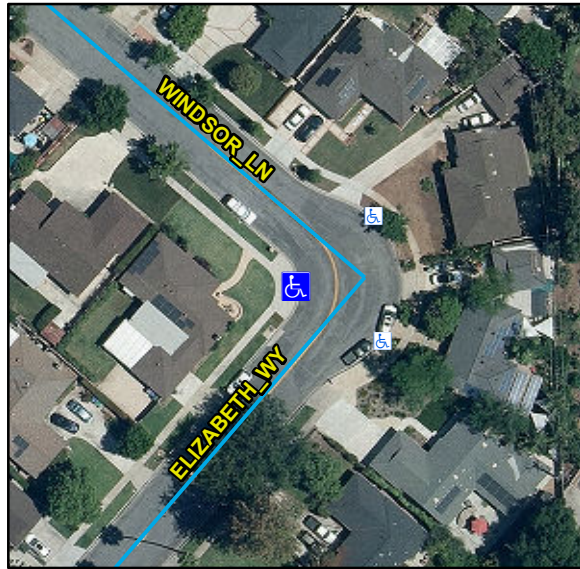
| Compliance | Description | Data | Compliance | Description | Data |
|---|---|---|---|---|---|
| No | Ramp Run Slope (%) | 9.6 | N/A | Flare Slope LT (%) | N/A |
| No | Ramp Cross Slope (%) | 4.2 | N/A | Flare Traversable LT | N/A |

Remove & Replace Curb Ramp With Two New Directional Ramps or Equivalent.

R204.3, R304.2.2, R304.5.3, STD 1115
