# Access Compliance Report Public Rights-of-Way (Curb Ramps)

Main Street: ENRAMADA\_DR Cross Street: WINDSOR\_LN Location: NW

ADA ID: RPAT211011110719 Ramp Type: Type 6 - Directional 1 Initial Pass/Fail: Pass Overall Compliance: No Severity Score: 2

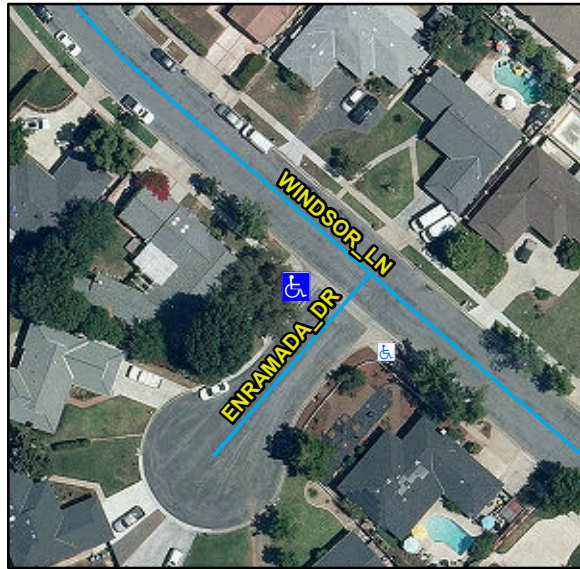
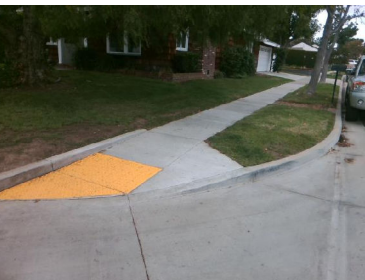
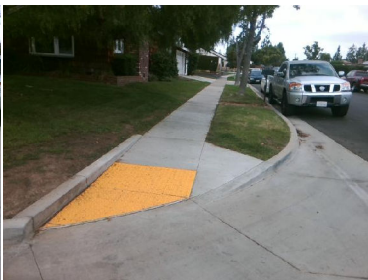
| Compliance | Description | Data | Compliance | Description | Data |
|---|---|---|---|---|---|
| No | Grade Break | No | N/A | Flare Type RT | |

Remove & Replace Entire Ramp.

R304.5.2, STD 1115

\$ 531
