# Access Compliance Report Public Rights-of-Way (Curb Ramps)

Main Street: WINDSOR\_LN Cross Street: ENRAMADA\_DR Location: SW

ADA ID: RPAT21101111117 Ramp Type: Type 6 - Directional 1 Initial Pass/Fail: Fail Overall Compliance: No Severity Score: 4

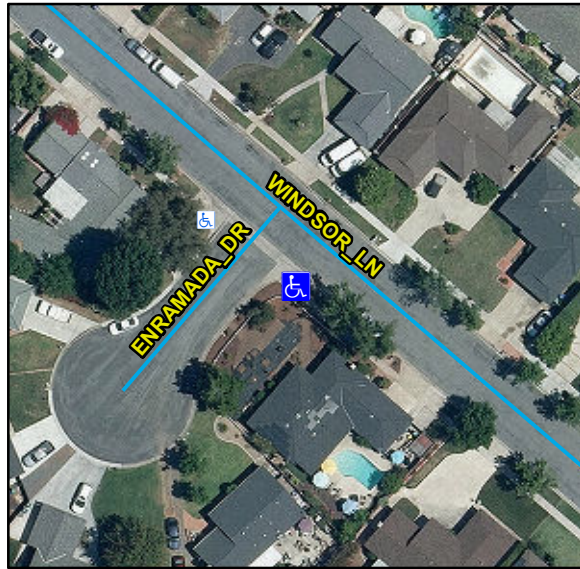
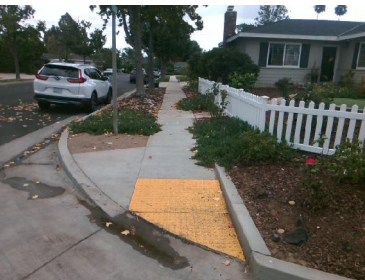
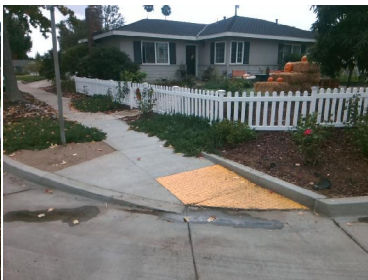
| Compliance | Description | Data | Compliance | Description | Data |
|---|---|---|---|---|---|
| No | Ramp Width (in) | 47 | | | N/A |

Remove & Replace Curb Ramp With Two New Directional Ramps or Equivalent.
