# Access Compliance Report Public Rights-of-Way (Curb Ramps)

Main Street: BULLARD\_RD Cross Street: BULLARD\_RD Location: NW

ADA ID: RPAT211011133511 Ramp Type: Type 3 - Combination 1 Initial Pass/Fail: Fail Overall Compliance: No Severity Score: 15

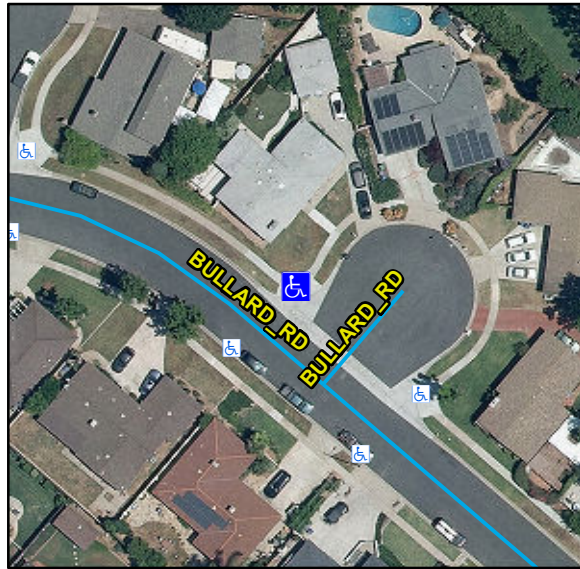
| Compliance | Description | Data | Compliance | Description | Data |
|---|---|---|---|---|---|
| No | Ramp Cross Slope LT (%) | 2.7 | Yes | Ramp Cross Slope RT (%) | 0.4 |
| No | Ramp Run Slope (%) | 8.5 | N/A | Flare Slope LT (%) | N/A |

Remove & Replace Curb Ramp With Two New Directional Ramps or Equivalent.

R304.2.2, R304.5.3, STD 1115
