# Access Compliance Report Public Rights-of-Way (Curb Ramps)

| Main Street: BROWNING_AVE | | Cross Street: RIVERFORD_RD | | Location: | NW |
| ADA ID: RPAT211012104451 | Ramp Type: Type 4 - Parallel | Initial Pass/Fail: Fail | Overall Compliance: No | Severity Score: | 16 |

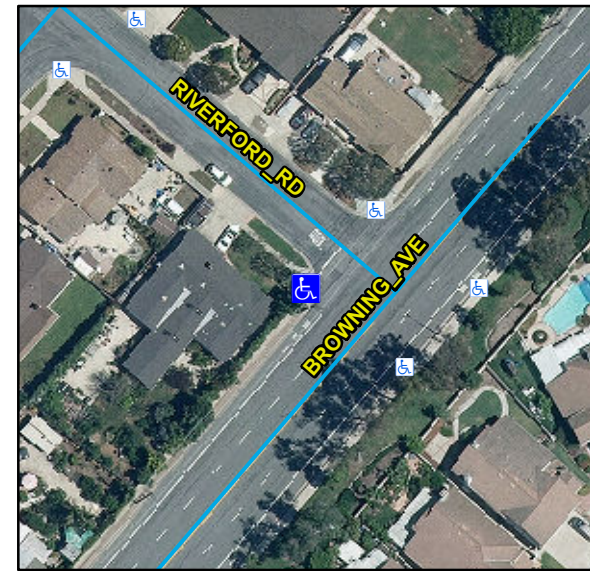
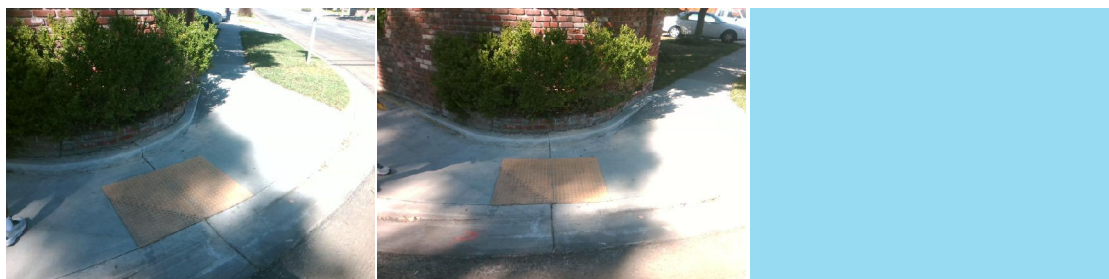
| Compliance | Description | Data | Compliance | Description | Data |
|---|---|---|---|---|---|
| Yes | Ramp Run Slope LT (%) | 5 | No | Ramp Run Slope RT (%) | 9.3 |
| Yes | Ramp Cross Slope LT (%) | 1.1 | No | Ramp Cross Slope RT (%) | 2.8 |

**Remove & Replace Curb Ramp With Two New Directional Ramps or Equivalent.**

**R304.3.2, R304.5.3, STD 1115**
