# Access Compliance Report Public Rights-of-Way (Curb Ramps)

Main Street: RIVERFORD\_RD Cross Street: BROWNING\_AVE Location: NE

ADA ID: RPAT211012104906 Ramp Type: Type 4 - Parallel Initial Pass/Fail: Fail Overall Compliance: No Severity Score: 16

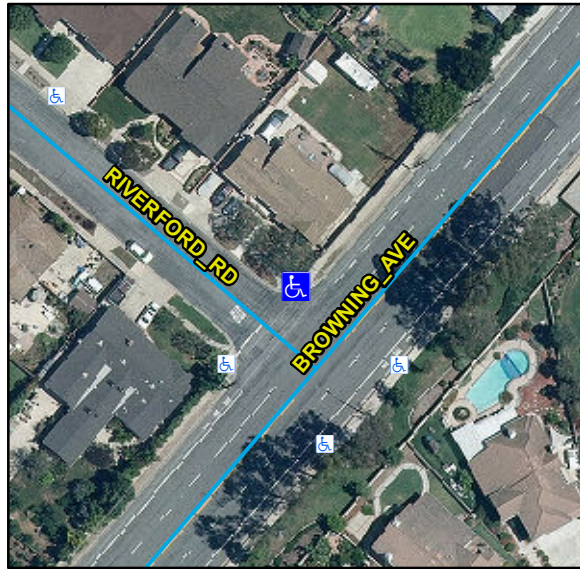
| Compliance | Description | Data | Compliance | Description | Data |
|---|---|---|---|---|---|
| Yes | Ramp Run Slope LT (%) | 4.2 | No | Ramp Run Slope RT (%) | 8.7 |
| Yes | Ramp Cross Slope LT (%) | 0.6 | No | Ramp Cross Slope RT (%) | 2.4 |

Remove & Replace Curb Ramp With Two New Directional Ramps or Equivalent.

R304.3.2, R304.5.3, STD 1115
