# Access Compliance Report Public Rights-of-Way (Curb Ramps)

Main Street: BURNT\_MILL\_RD Cross Street: BROWNING\_AVE Location: NE

ADA ID: RPAT211012105431 Ramp Type: Type 4 - Parallel Initial Pass/Fail: Pass Overall Compliance: No Severity Score: 20

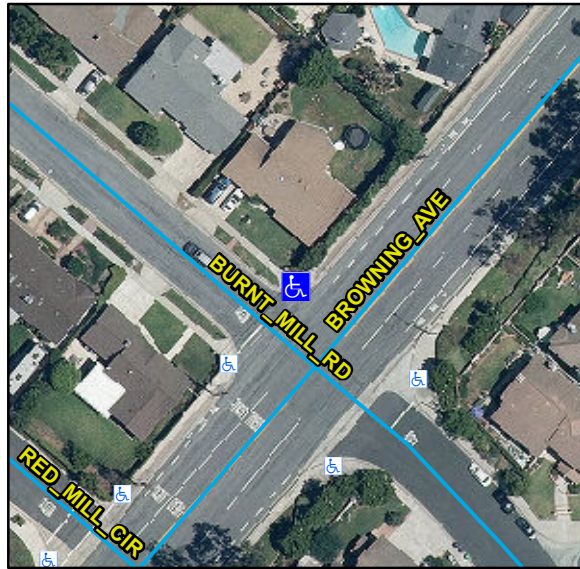
R204.3, R304.2.1, R304.2.2-Perp, R304.3.2-Para, R305, R304.5.4, STD 1115

| Compliance | Description | Data | Compliance | Description | Data |
|---|---|---|---|---|---|
| N/A | Landing Present | Yes | No | DWS Provided | No |
| No | Landing Run Slope (%) | 4.5 | N/A | DWS Full Width | N/A |
| No | Gutter Run Slope (%) | 5.2 | | Road Cross Slope (%) | 5.5 |
| Yes | Gutter Cross Slope (%) | 0 | No | Perpendicular Joint Present | No |

Remove & Replace Curb Ramp With Two New Directional Ramps or Equivalent. Remove & Replace Gutter.
