# Access Compliance Report Public Rights-of-Way (Curb Ramps)

Main Street: **BROWNING\_AVE** Cross Street: **BURNT\_MILL\_RD** Location: **NW**

ADA ID: **RPAT211012105815** Ramp Type: **Type 4 - Parallel** Initial Pass/Fail: **Fail** Overall Compliance: **No** Severity Score: **2**

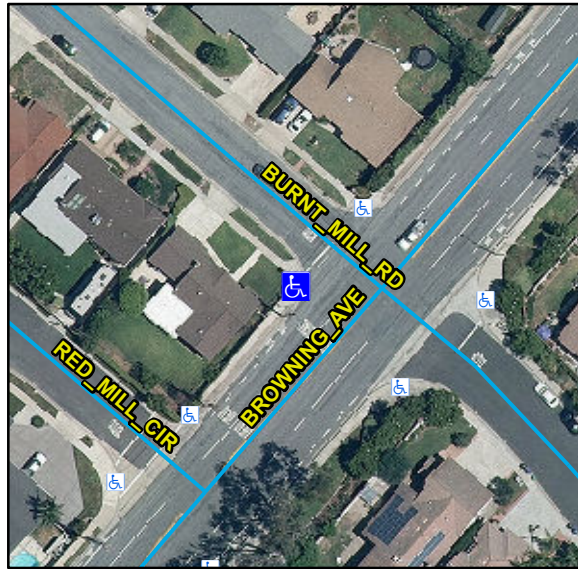
| Compliance | Description | Data | Compliance | Description | Data |
|---|---|---|---|---|---|
| <b>Yes</b> | Ramp Cross Slope LT (%) | <b>1.1</b> | <b>No</b> | Ramp Cross Slope RT (%) | <b>2.6</b> |

**Remove & Replace Curb Ramp With Two New Directional Ramps or Equivalent.**

**R304.5.3, STD 1115**
