# Access Compliance Report Public Rights-of-Way (Curb Ramps)

Main Street: BURNT\_MILL\_RD Cross Street: BROWNING\_AVE Location: SW

ADA ID: RPAT211012110103 Ramp Type: Type 1 - Perpendicular Diagonal Initial Pass/Fail: Pass Overall Compliance: No Severity Score: 18

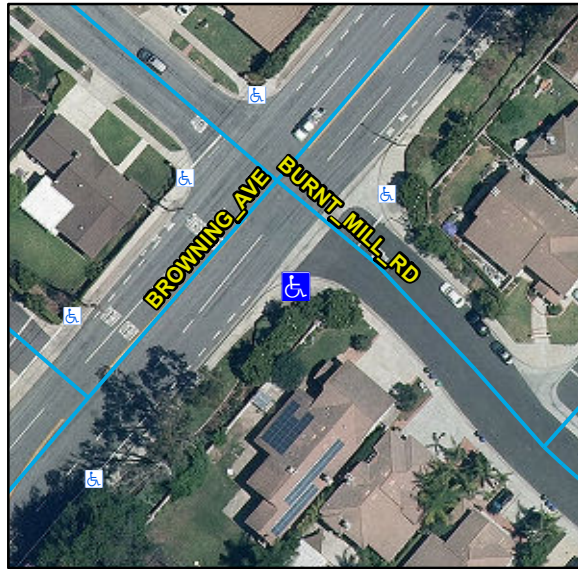
| Compliance | Description | Data | Compliance | Description | Data |
|---|---|---|---|---|---|
| Yes | Ramp Run Slope (%) | 6.1 | No | Flare Slope LT (%) | 11.1 |

Remove & Replace Curb Ramp With Two New Directional Ramps or Equivalent. Remove & Replace Gutter.

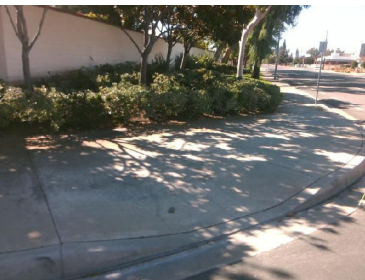
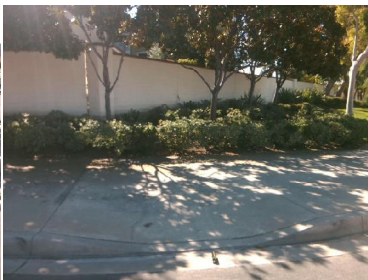
| Compliance | Description | Data | Compliance | Description | Data |
|---|---|---|---|---|---|
| Yes | Landing Width (in) | 117 | No | Flare Slope RT (%) | 11.2 |
| Yes | Landing Cross Slope (%) | 0.7 | No | DWS Provided | No |
| No | Gutter Run Slope (%) | 13.5 | | Road Cross Slope (%) | 2.7 |
| No | Gutter Cross Slope (%) | 2.9 | | | |
