# Access Compliance Report Public Rights-of-Way (Curb Ramps)

Main Street: **BROWNING\_AVE** Cross Street: **BURNT\_MILL\_RD** Location: **SE**

ADA ID: **RPAT211012110443** Ramp Type: **Type 1 - Perpendicular Diagonal Initial Pass/Fail: Pass** Overall Compliance: **No** Severity Score: **10**

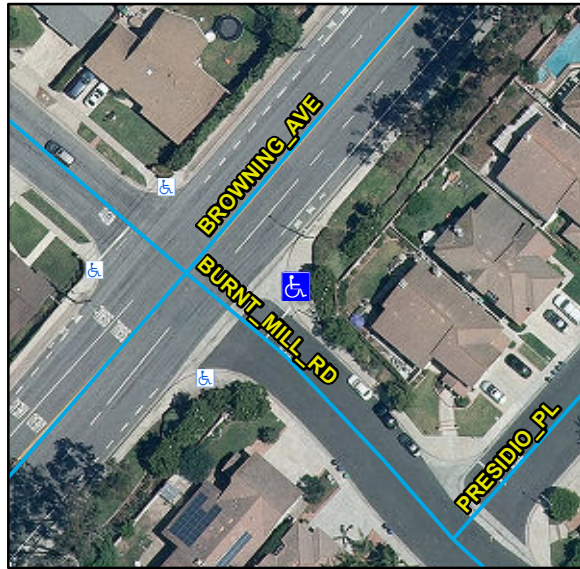
| Compliance | Description | Data | Compliance | Description | Data |
|---|---|---|---|---|---|
| Yes | Landing Cross Slope (%) | 1.8 | No | DWS Provided | No |

**Remove & Replace Curb Ramp With Two New Directional Ramps or Equivalent.**
