# Access Compliance Report

## Public Rights-of-Way

### (Curb Ramps)

Main Street: N/A Cross Street: BROWNING\_AVE Location: NE

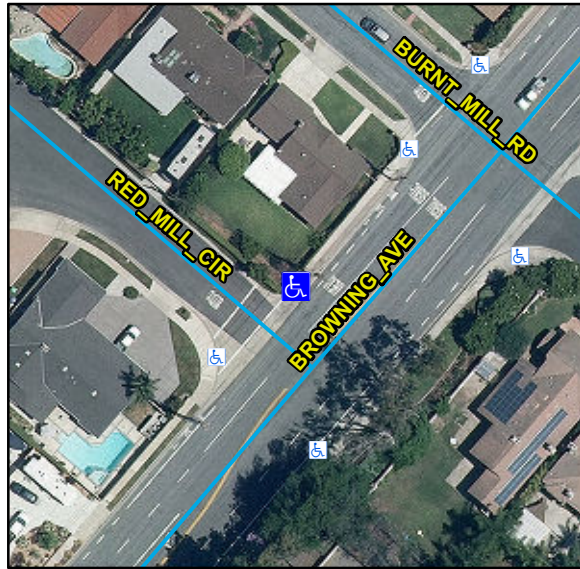
ADA ID: RPAT211012110845 Ramp Type: Type 6 - Directional 1 Initial Pass/Fail: Fail Overall Compliance: No Severity Score: 2

| Compliance | Description | Data | Compliance | Description | Data |
|---|---|---|---|---|---|
| No | Ramp Cross Slope (%) | 3.1 | N/A | Flare Traversable LT | N/A |

Remove & Replace Curb Ramp With Two New Directional Ramps or Equivalent.

R304.5.3, STD 1115
