# Access Compliance Report Public Rights-of-Way (Curb Ramps)

Main Street: **BROWNING\_AVE** Cross Street: **RED\_MILL\_CIR** Location: **NW**

ADA ID: **RPAT211012111204** Ramp Type: **Type 3 - Combination 1** Initial Pass/Fail: **Fail** Overall Compliance: **No** Severity Score: **35**

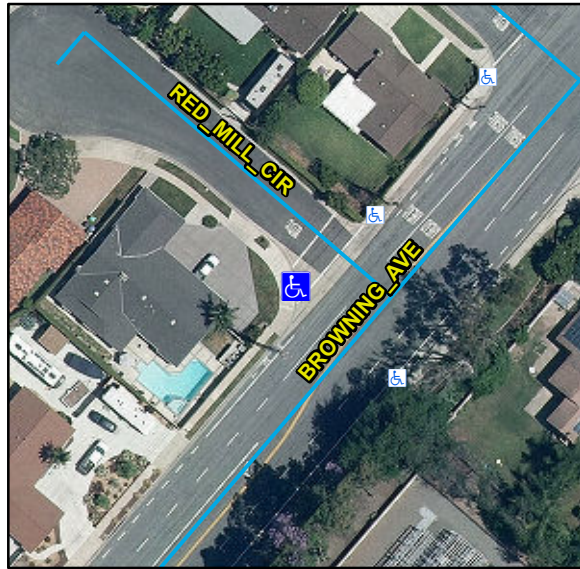
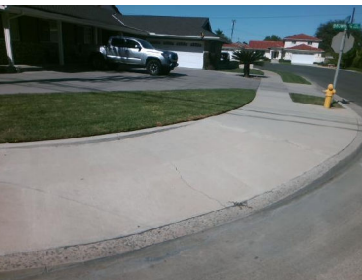
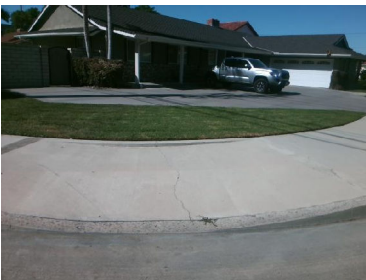
| Compliance | Description | Data | Compliance | Description | Data |
|---|---|---|---|---|---|
| <b>No</b> | Ramp Width LT (in) | <b>45</b> | <b>No</b> | Ramp Width RT (in) | <b>45</b> |
| <b>No</b> | Ramp Cross Slope LT (%) | <b>4.6</b> | <b>No</b> | Ramp Cross Slope RT (%) | <b>2.8</b> |
| <b>No</b> | Ramp Run Slope (%) | <b>12.6</b> | <b>N/A</b> | Flare Slope LT (%) | <b>N/A</b> |
| <b>No</b> | Perp Joint Present | <b>No</b> | | | |
| <b>N/A</b> | Gutter Ponding | <b>N/A</b> | <b>No</b> | Curb Slope | <b>7.5</b> |

**Remove & Replace Curb Ramp With Two New Directional Ramps or Equivalent.**

**R304.2.2, R204.3, R304.5.1, R304.5.3, STD 1115**
