# Access Compliance Report Public Rights-of-Way (Curb Ramps)

| Main Street: WOODLAWN_AVE | | Cross Street: SKYLINE_DR | | Location: | NW |
| ADA ID: RPAT211012132342 | Ramp Type: Type 6 - Directional 1 | Initial Pass/Fail: Fail | Overall Compliance: No | Severity Score: | 2 |

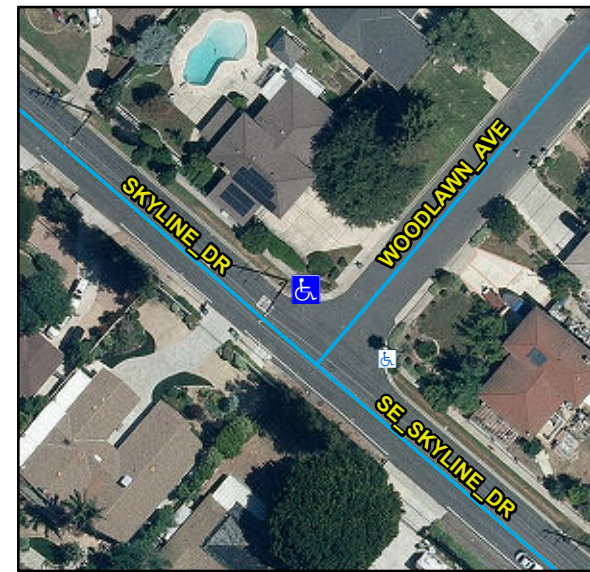
| Compliance | Description | Data | Compliance | Description | Data |
|---|---|---|---|---|---|
| No | Ramp Cross Slope (%) | 2.5 | N/A | Flare Traversable LT | N/A |

Possible Solutions:

Remove & Replace Entire Ramp.

R304.5.3, STD 1115
