# Access Compliance Report Public Rights-of-Way (Curb Ramps)

Main Street: KENWOOD\_LN Cross Street: SIERRA\_ALTA\_DR Location: SE

ADA ID: RPAT211013083951 Ramp Type: Type 6 - Directional 1 Initial Pass/Fail: Pass Overall Compliance: No Severity Score: 4

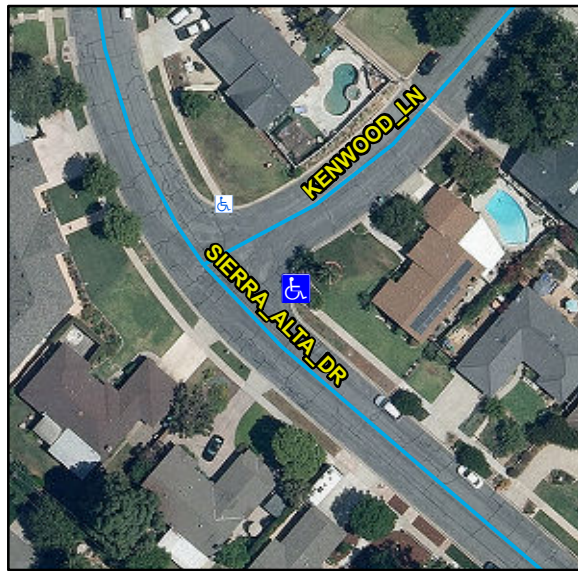
R304.2.1, STD 1115

| Compliance | Description | Data | Compliance | Description | Data |
|---|---|---|---|---|---|
| No | Landing Length (in) | 47 | Yes | DWS Length (in) | 75 |

Remove & Replace Landing.
