# Access Compliance Report Public Rights-of-Way (Curb Ramps)

Main Street: WOODLAWN\_AVE Cross Street: SIERRA\_ALTA\_DR Location: SE

ADA ID: RPAT211013085118 Ramp Type: Type 1 - Perpendicular Diagonal Initial Pass/Fail: Pass Overall Compliance: No Severity Score: 2

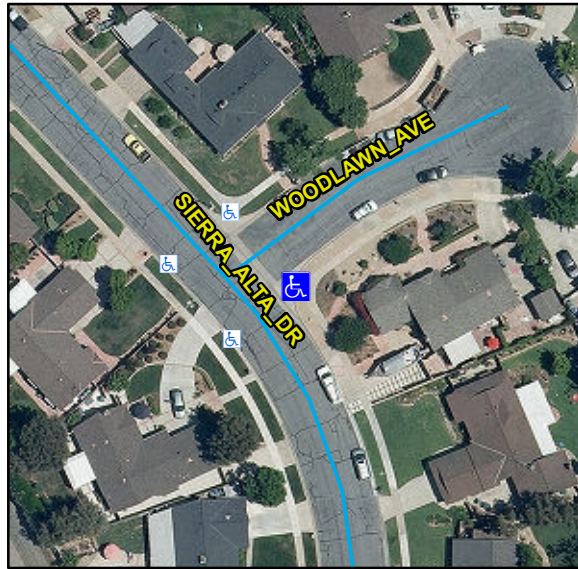
| Compliance | Description | Data | Compliance | Description | Data |
|---|---|---|---|---|---|
| No | Ramp Cross Slope (%) | 2.1 | N/A | Flare Traversable LT | Yes |

Remove & Replace Curb Ramp With Two New Directional Ramps or Equivalent.

R304.5.3, STD 1115
