# Access Compliance Report Public Rights-of-Way (Curb Ramps)

Main Street: SIERRA\_ALTA\_DR Cross Street: WOODLAWN\_AVE Location: NE

ADA ID: RPAT211013085523 Ramp Type: Type 1 - Perpendicular Diagonal Initial Pass/Fail: Pass Overall Compliance: No Severity Score: 5

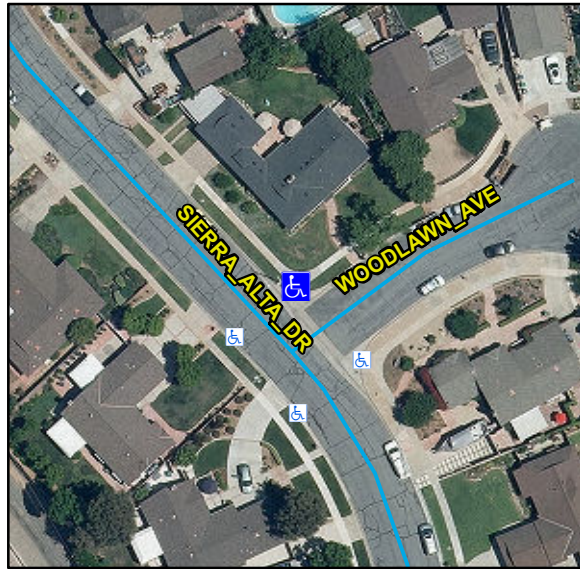
| Compliance | Description | Data | Compliance | Description | Data |
|---|---|---|---|---|---|
| Yes | Gutter Ponding | No | No | Curb Slope | 5.8 |
| No | Gutter Run Slope (%) | 7.1 | | Road Cross Slope (%) | 8.4 |

Remove & Replace Curb Ramp With Two New Directional Ramps or Equivalent. Remove & Replace Gutter.

R304.2.2, R304.2.1, R304.5.4, STD 1115

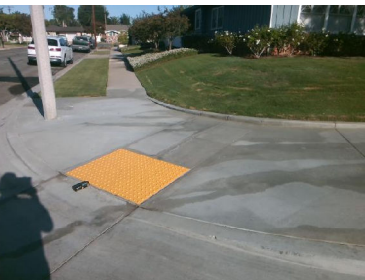
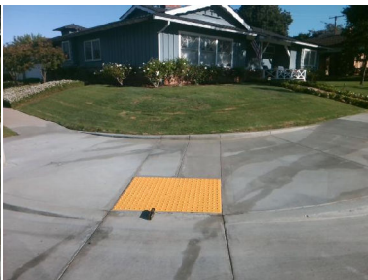
| Compliance | Description | Data | Compliance | Description | Data |
|---|---|---|---|---|---|
| Yes | Overall Surface Condition: Acceptable | | Yes | Perp Joint Present | Yes |
| | Cross Gutter Present? | Yes | | Spandrel Present? | Yes |
