# Access Compliance Report Public Rights-of-Way (Curb Ramps)

| Main Street: BROWNING_AVE | | Cross Street: COVENTRY_PL | | Location: | SE |
| ADA ID: RPAT211013101052 | Ramp Type:Type 1 - Perpendicular | Initial Pass/Fail: Pass | Overall Compliance: No | Severity Score: | 12 |

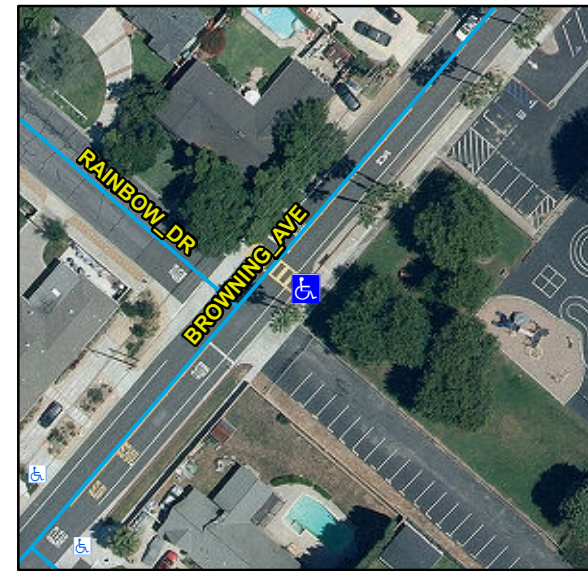
| Compliance | Description | Data | Compliance | Description | Data |
|---|---|---|---|---|---|
| Yes | Ramp Run Slope (%) | 7.3 | No | Flare Slope LT (%) | 13.2 |
| Yes | Landing Width (in) | 49 | N/A | Flare Slope RT (%) | 13.7 |
| Yes | Gutter Ponding | No | No | Curb Slope | 7 |
| No | Gutter Run Slope (%) | 10.4 | | Road Cross Slope (%) | N/A |

**Remove & Replace Entire Ramp. Remove & Replace Gutter.**

**R304.2.2, R304.2.1, R304.2.3, R304.5.4, STD 1115**
