# Access Compliance Report Public Rights-of-Way (Curb Ramps)

| Main Street: SHELTERWOOD_RD | | Cross Street: RANCHWOOD_RD | | Location: | NW |
| ADA ID: RPAT211013103250 | Ramp Type: Type 4 - Parallel | Initial Pass/Fail: Pass | Overall Compliance: No | Severity Score: | 0 |

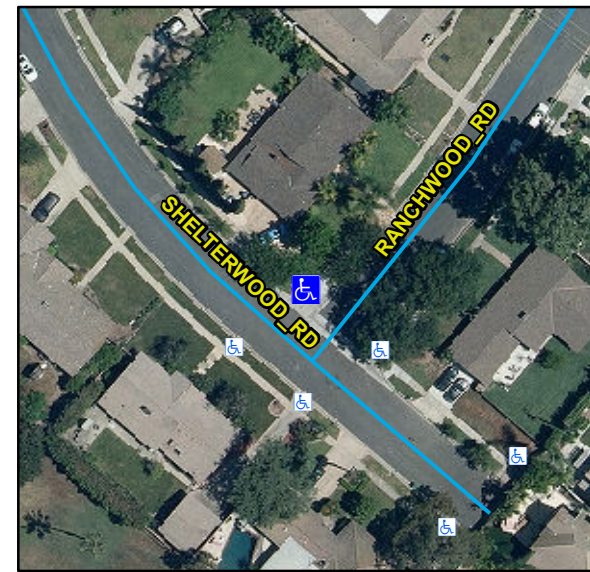
| Compliance | Description | Data | Compliance | Description | Data |
|---|---|---|---|---|---|
| Yes | Gutter Ponding | No | No | Curb Slope | 9.1 |
| Yes | Gutter Cross Slope (%) | 0.9 | No | Perpendicular Joint Present | No |

**Remove & Replace Curb Ramp With Two New Directional Ramps or Equivalent.**

**R304.2.2, R204.3, STD 1115**

Total Cost: \$ 4000
