# Access Compliance Report Public Rights-of-Way (Curb Ramps)

Main Street: RANCHWOOD\_RD Cross Street: SHELTERWOOD\_RD Location: SE

ADA ID: RPAT211013103721 Ramp Type: Type 4 - Parallel Initial Pass/Fail: Fail Overall Compliance: No Severity Score: 2

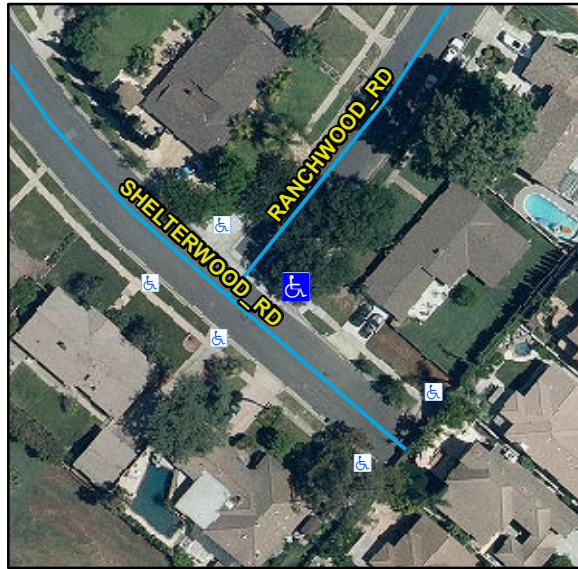
| Compliance | Description | Data | Compliance | Description | Data |
|---|---|---|---|---|---|
| Yes | Ramp Cross Slope LT (%) | 1.2 | No | Ramp Cross Slope RT (%) | 3.1 |

**Remove & Replace Curb Ramp With Two New Directional Ramps or Equivalent.**

**R304.5.3, STD 1115**
