# Access Compliance Report Public Rights-of-Way (Curb Ramps)

Main Street: FAIR\_WEATHER\_RD Cross Street: RANCHWOOD\_RD Location: SE

ADA ID: RPAT211013135137 Ramp Type: Type 1 - Perpendicular Diagonal Initial Pass/Fail: Fail Overall Compliance: No Severity Score: 16

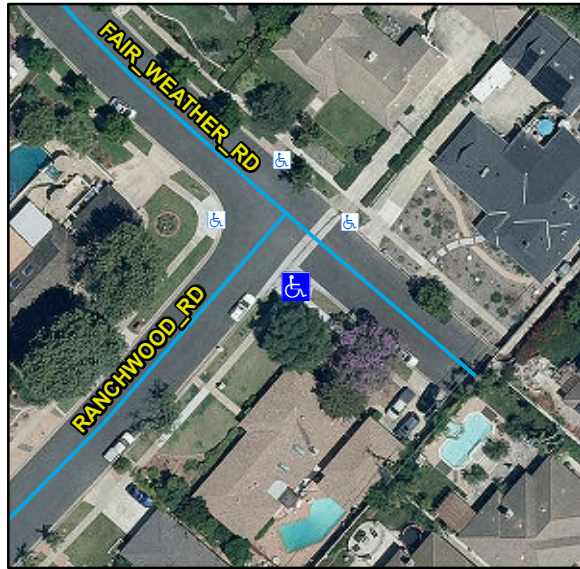
R304.2.2, R304.5.3, STD 1115

| Compliance | Description | Data | Compliance | Description | Data |
|---|---|---|---|---|---|
| No | Ramp Run Slope (%) | 8.7 | N/A | Flare Slope LT (%) | N/A |
| No | Ramp Cross Slope (%) | 2.3 | N/A | Flare Traversable LT | N/A |

Remove & Replace Curb Ramp With Two New Directional Ramps or Equivalent.
