# Access Compliance Report Public Rights-of-Way (Curb Ramps)

Main Street: INWOOD\_DR Cross Street: RANCHWOOD\_RD Location: NW

ADA ID: RPAT211013135652 Ramp Type: Type 1 - Perpendicular Diagonal Initial Pass/Fail: Pass Overall Compliance: No Severity Score: 6

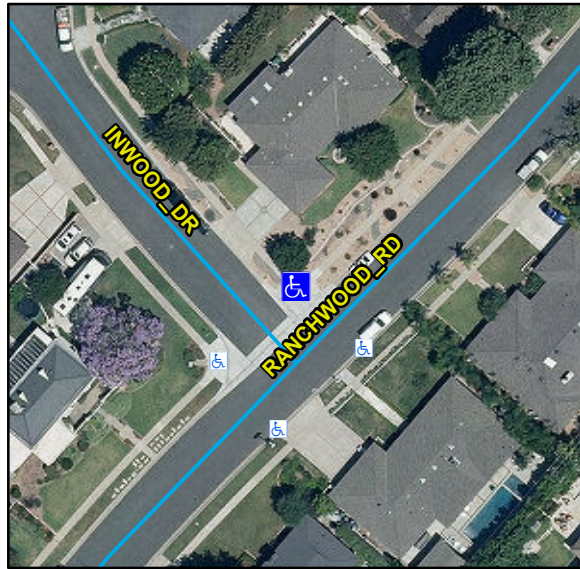
| Compliance | Description | Data | Compliance | Description | Data |
|---|---|---|---|---|---|
| Yes | Gutter Ponding | No | No | Curb Slope | 9.9 |

Remove & Replace Curb Ramp With Two New Directional Ramps or Equivalent.

R304.2.2, R304.2.1, STD 1115
