# Access Compliance Report Public Rights-of-Way (Curb Ramps)

| Main Street: RANCHWOOD_RD | | Cross Street: INWOOD_DR | | Location: | NW |
| ADA ID: RPAT211013140241 | Ramp Type:Type 1 - Perpendicular Diagonal Initial Pass/Fail: Fail | | Overall Compliance: No | Severity Score: | 0 |

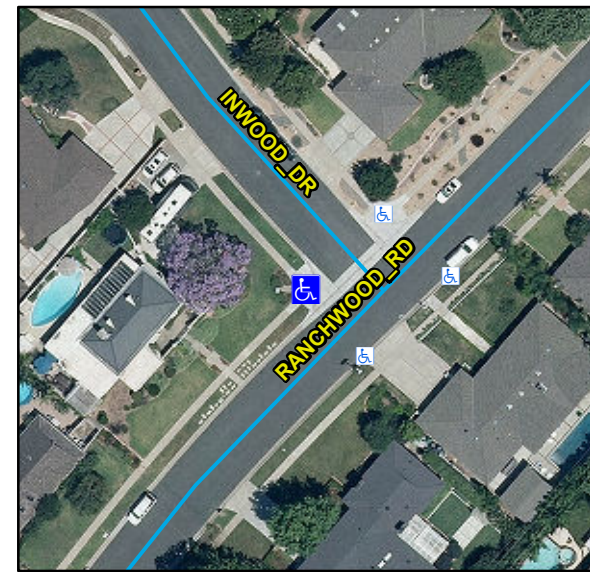
**R304.2.2, STD 1115**

Possible Solutions:

**Remove & Replace Curb Ramp With Two New Directional Ramps or Equivalent.**

Total Cost: \$ 6160
