# Access Compliance Report Public Rights-of-Way (Curb Ramps)

Main Street: RANCHWOOD\_RD Cross Street: REDBERRY\_RD Location: NE

ADA ID: RPAT211013142806 Ramp Type: Type 1 - Perpendicular Diagonal Initial Pass/Fail: Pass Overall Compliance: No Severity Score: 6

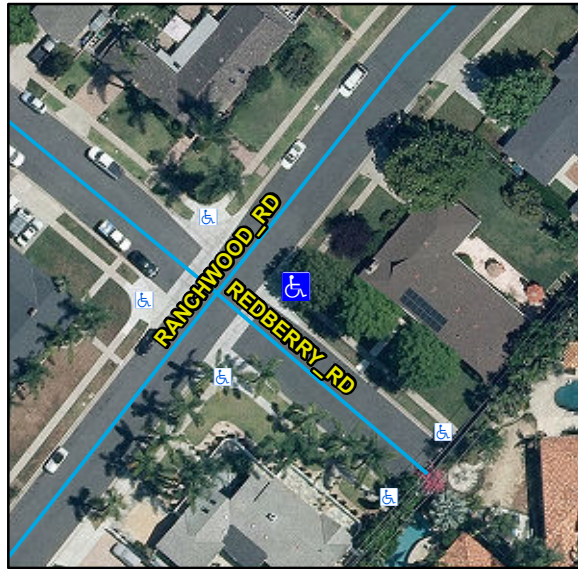
| Compliance | Description | Data | Compliance | Description | Data |
|---|---|---|---|---|---|
| Yes | Gutter Ponding | No | No | Curb Slope | 11 |

Remove & Replace Curb Ramp With Two New Directional Ramps or Equivalent.

R304.2.2, R304.2.1, STD 1115
