# Access Compliance Report Public Rights-of-Way (Curb Ramps)

| Main Street: REDBERRY_RD | | Cross Street: RANCHWOOD_RD | | Location: | SE |
| ADA ID: RPAT211013144355 | Ramp Type: Type 3 - Combination 1 | Initial Pass/Fail: Pass | Overall Compliance: No | Severity Score: | 0 |

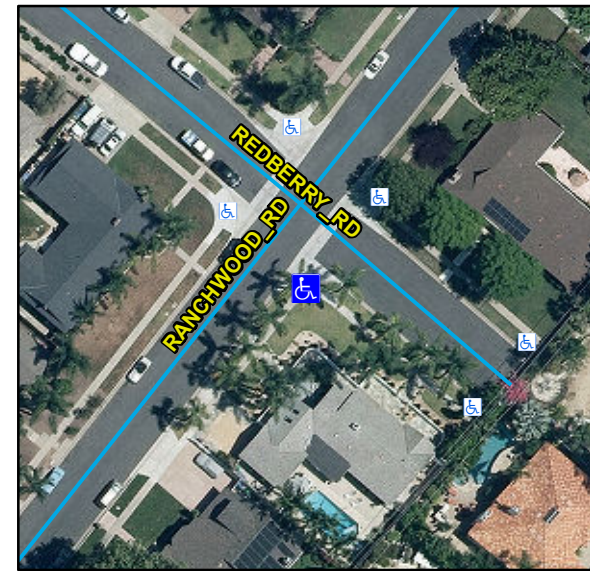
| Compliance | Description | Data | Compliance | Description | Data |
|---|---|---|---|---|---|
| Yes | Ramp Cross Slope LT (%) | 1 | No | Ramp Cross Slope RT (%) | 2.4 |
| Yes | Gutter Ponding | No | No | Curb Slope | 12.1 |

Possible Solutions:

**Remove & Replace Curb Slope. Remove & Replace Sidewalk.**

**R304.2.2, R304.5.3, STD 1115**

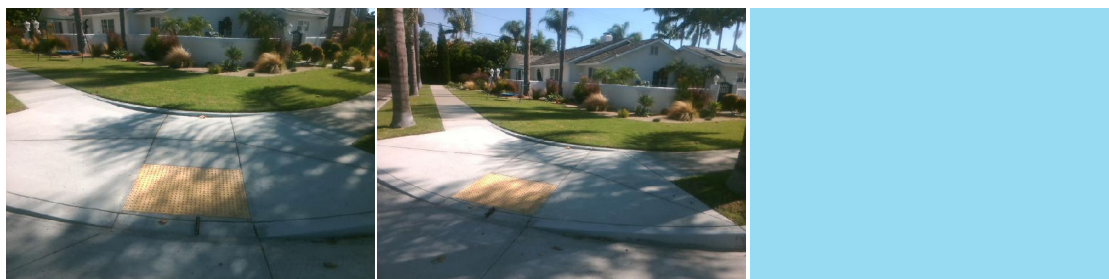
| Compliance | Description | Data | Compliance | Description | Data |
|---|---|---|---|---|---|
| N/A | Ramp Length LT (in) | 88 | N/A | Ramp Length RT (in) | 33 |
| Yes | Ramp Width LT (in) | 52 | Yes | Ramp Width RT (in) | 55 |
| Yes | Ramp Run Slope LT (%) | 7.6 | Yes | Ramp Run Slope RT (%) | 0.9 |
