# Access Compliance Report Public Rights-of-Way (Curb Ramps)

Main Street: RANCHWOOD\_RD Cross Street: EVENINGSIDE\_DR Location: NW

ADA ID: RPAT211013145452 Ramp Type: Type 3 - Combination 1 Initial Pass/Fail: Fail Overall Compliance: No Severity Score: 2

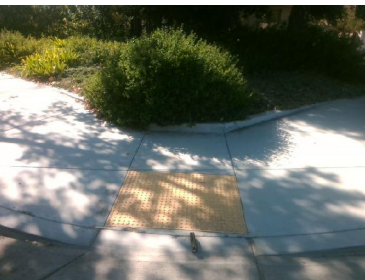
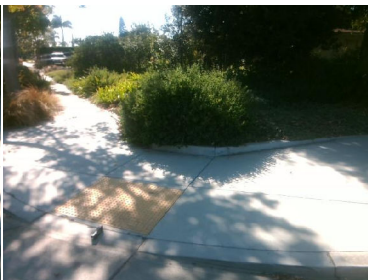
| Compliance | Description | Data | Compliance | Description | Data |
|---|---|---|---|---|---|
| Yes | Ramp Cross Slope LT (%) | 0.8 | No | Ramp Cross Slope RT (%) | 2.8 |
| N/A | Gutter Ponding | N/A | No | Curb Slope | 6.7 |

Remove & Replace Curb Ramp With Two New Directional Ramps or Equivalent.

R304.2.2, R304.5.3, STD 1115
