# Access Compliance Report Public Rights-of-Way (Curb Ramps)

| Main Street: GIGI_DR | | Cross Street: SMOKE_TREE_LN | | Location: | W |
| ADA ID: RPAT211014100940 | Ramp Type: Type 3 - Combination 1 | Initial Pass/Fail: Fail | Overall Compliance: No | Severity Score: | 19 |

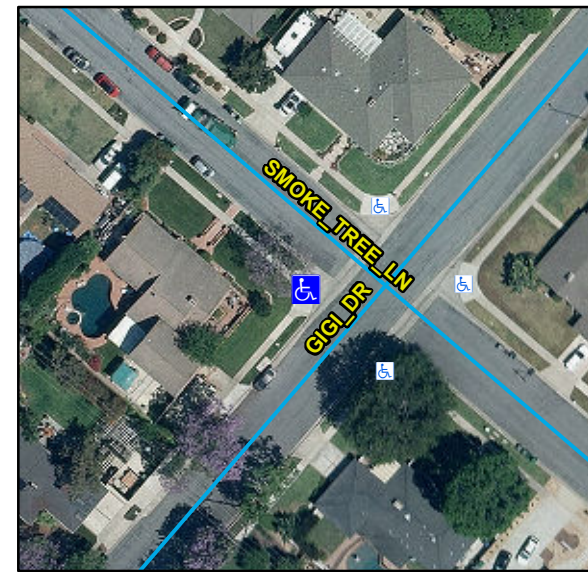
| Compliance | Description | Data | Compliance | Description | Data |
|---|---|---|---|---|---|
| No | Ramp Width LT (in) | 46 | Yes | Ramp Width RT (in) | 56 |
| Yes | Ramp Cross Slope LT (%) | 0.2 | No | Ramp Cross Slope RT (%) | 2.2 |
| No | Ramp Run Slope (%) | 8.8 | N/A | Flare Slope LT (%) | N/A |

**Remove & Replace Curb Ramp With Two New Directional Ramps or Equivalent.**

**R304.5.1, R304.2.2, R304.5.3, STD 1115**

Total Cost: \$ 6160

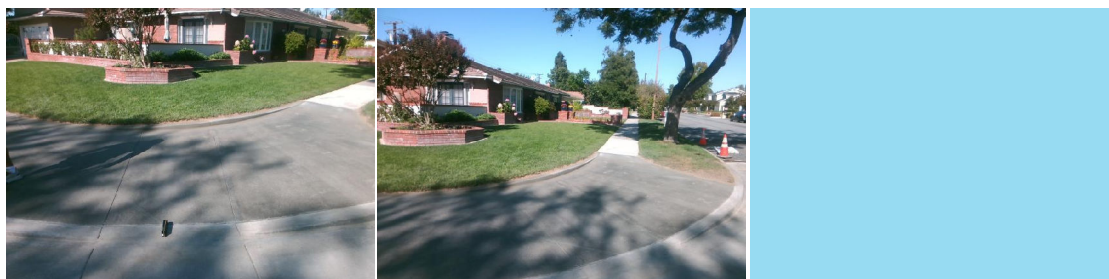
| Compliance | Description | Data | Compliance | Description | Data |
|---|---|---|---|---|---|
| N/A | Ramp Length LT (in) | 141 | N/A | Ramp Length RT (in) | 125 |
| Yes | Ramp Run Slope LT (%) | 2.5 | Yes | Ramp Run Slope RT (%) | 7.6 |
