# Access Compliance Report Public Rights-of-Way (Curb Ramps)

Main Street: SILVER\_MAPLE\_WAY Cross Street: HEWES\_AVE Location: SE

ADA ID: RPAT211014135615 Ramp Type: Type 1 - Perpendicular Diagonal Initial Pass/Fail: Pass Overall Compliance: No Severity Score: 5

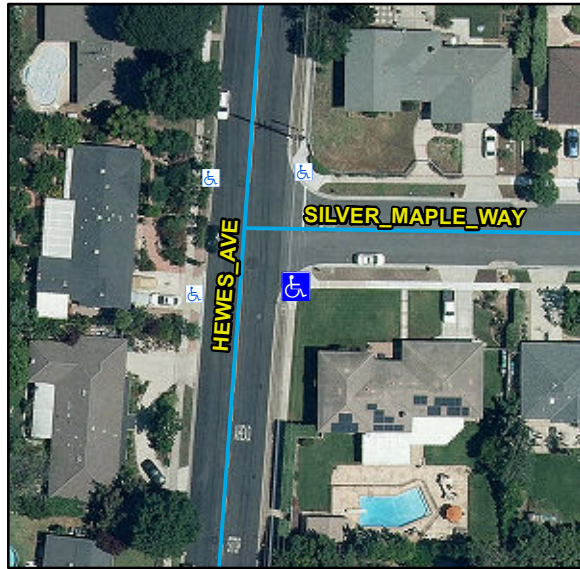
| Compliance | Description | Data | Compliance | Description | Data |
|---|---|---|---|---|---|
| Yes | Gutter Ponding | No | No | Curb Slope | 5.1 |
| No | Gutter Run Slope (%) | 6.3 | | Road Cross Slope (%) | 0.7 |
| No | Gutter Cross Slope (%) | 2.7 | | | |

Remove & Replace Curb Ramp With Two New Directional Ramps or Equivalent. Remove & Replace Gutter.
