# Access Compliance Report Public Rights-of-Way (Curb Ramps)

Main Street: HEWES\_AVE Cross Street: SILVER\_MAPLE\_WAY Location: NE

ADA ID: RPAT211014140059 Ramp Type: Type 1 - Perpendicular Diagonal Initial Pass/Fail: Pass Overall Compliance: No Severity Score: 5

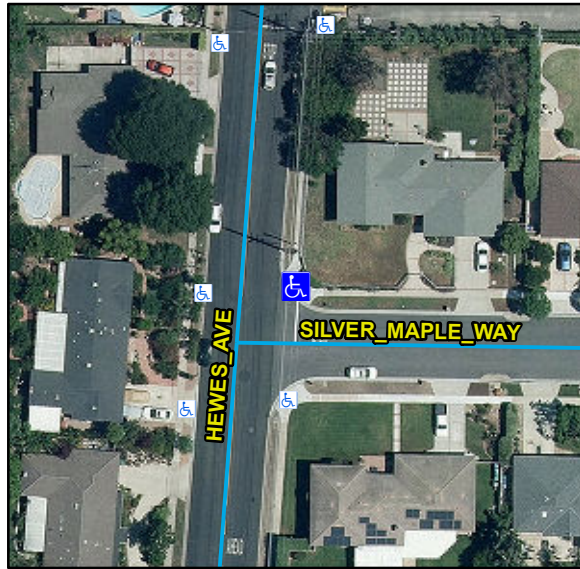
| Compliance | Description | Data | Compliance | Description | Data |
|---|---|---|---|---|---|
| Yes | Gutter Ponding | No | No | Curb Slope | 6.1 |
| No | Gutter Run Slope (%) | 6 | | Road Cross Slope (%) | 6.6 |

Remove & Replace Curb Slope. Remove & Replace Gutter.

R304.2.2, R304.5.4, STD 1115

Total Cost: \$ 504
