# Access Compliance Report Public Rights-of-Way (Curb Ramps)

Main Street: HEWES\_AVE Cross Street: BIKINI\_PL Location: NE

ADA ID: RPAT211015084909 Ramp Type: Type 4 - Parallel Initial Pass/Fail: Fail Overall Compliance: No Severity Score: 19

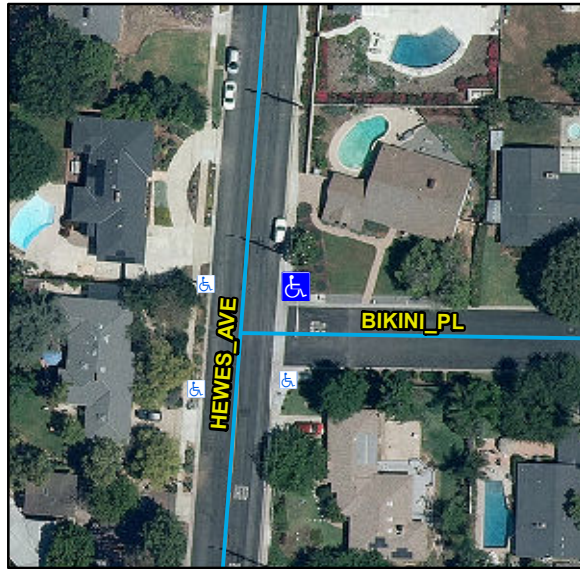
| Compliance | Description | Data | Compliance | Description | Data |
|---|---|---|---|---|---|
| Yes | Ramp Width LT (in) | 48 | No | Ramp Width RT (in) | 47 |
| No | Ramp Run Slope LT (%) | 8.4 | Yes | Ramp Run Slope RT (%) | 5.7 |

**Remove & Replace Curb Ramp With Two New Directional Ramps or Equivalent.**

**R304.5.1, R304.3.2, STD 1115**
