# Access Compliance Report Public Rights-of-Way (Curb Ramps)

Main Street: **BIKINI\_PL** Cross Street: **HEWES\_AVE** Location: **SE**

ADA ID: **RPAT211015085428** Ramp Type: **Type 4 - Parallel** Initial Pass/Fail: **Fail** Overall Compliance: **No** Severity Score: **4**

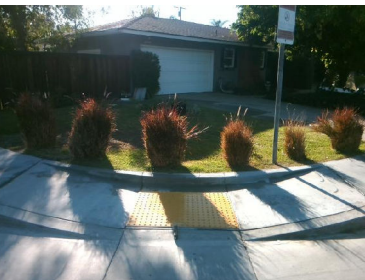
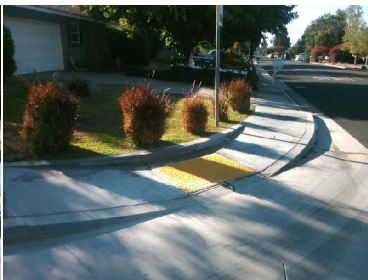
| Compliance | Description | Data | Compliance | Description | Data |
|---|---|---|---|---|---|
| <b>No</b> | Ramp Width LT (in) | <b>47</b> | <b>Yes</b> | Ramp Width RT (in) | <b>48</b> |

**Remove & Replace Curb Ramp With Two New Directional Ramps or Equivalent.**
