# Access Compliance Report Public Rights-of-Way (Curb Ramps)

Main Street: DODGE\_AVE Cross Street: HEWES\_AVE Location: SE

ADA ID: RPAT211015085913 Ramp Type: Type 4 - Parallel Initial Pass/Fail: Fail Overall Compliance: No Severity Score: 20

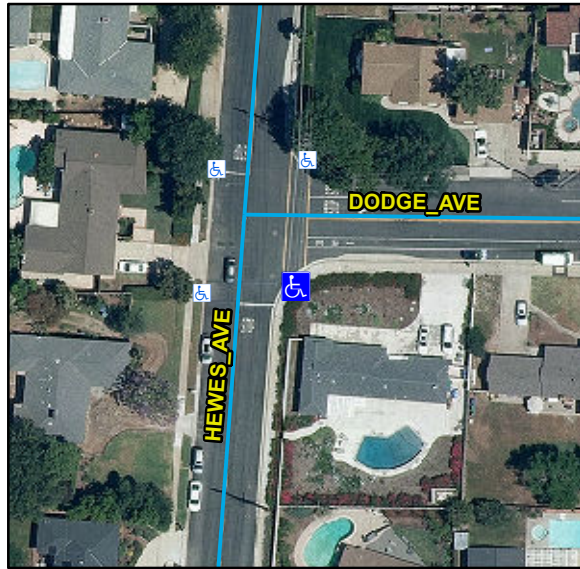
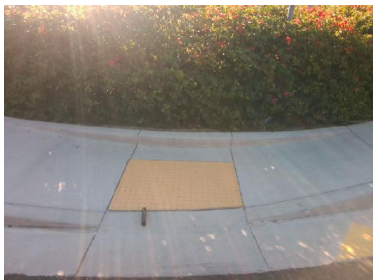
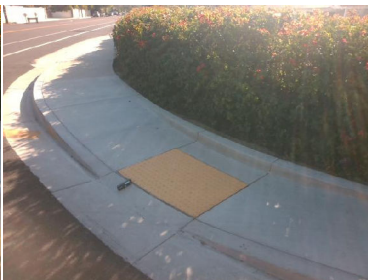
| Compliance | Description | Data | Compliance | Description | Data |
|---|---|---|---|---|---|
| Yes | Ramp Width LT (in) | 53 | No | Ramp Width RT (in) | 43 |
| No | Ramp Run Slope LT (%) | 9 | Yes | Ramp Run Slope RT (%) | 5.8 |

Remove & Replace Curb Ramp With Two New Directional Ramps or Equivalent.

R304.5.1, R304.3.2, STD 1115

Total Cost: \$ 4000
