# Access Compliance Report Public Rights-of-Way (Curb Ramps)

Main Street: HEWES\_AVE Cross Street: DODGE\_AVE Location: NE

ADA ID: RPAT211015090249 Ramp Type: Type 4 - Parallel Initial Pass/Fail: Fail Overall Compliance: No Severity Score: 4

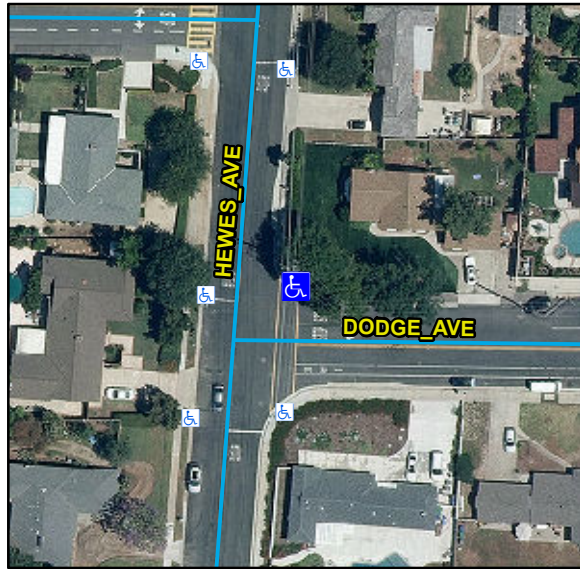
**R304.5.1, STD 1115**

| Compliance | Description | Data | Compliance | Description | Data |
|---|---|---|---|---|---|
| No | Ramp Width LT (in) | 47 | No | Ramp Width RT (in) | 47 |

**Remove & Replace Curb Ramp With Two New Directional Ramps or Equivalent.**
