## **Access Compliance Report Public Rights-of-Way** (Curb Ramps)

Main Street: HEWES AVE **Cross Street: DODGE AVE** Location: SW

ADA ID: RPAT211015090636 Ramp Type: Type 4 - Parallel **Initial Pass/Fail: Pass Overall Compliance: No Severity Score:**

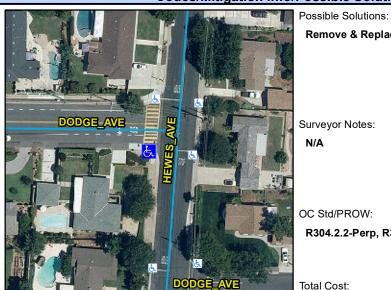
Field Measurements/Component Compliance									
	Compliance Description		Data	Com	pliance Description	Data			
	N/A	Ramp Length LT (in)	38	N/A	Ramp Length RT (in)	45			
	Yes	Ramp Width LT (in)	61	Yes	Ramp Width RT (in)	59			
	Yes	Ramp Run Slope LT (%)	2.5	Yes	Ramp Run Slope RT (%)	4.3			
	Yes	Ramp Cross Slope LT (%)	8.0	Yes	Ramp Cross Slope RT (%)	0.3			
	N/A	Landing Present	Yes	Yes	DWS Provided	Yes			
	N/A	Landing Length (in)	60	Yes	DWS Contrast	Yes			
	Yes	Landing Width (in)	48	Yes	DWS Length (in)	36			
	No	Landing Run Slope (%)	3.9	Yes	DWS Full Width	Yes			
	Yes	Landing Cross Slope (%)	0.4		DWS Offset Type	Single			
	N/A	Landing Movement Obstructed?	No	Yes	DWS Offset Left (in)	0			
		Landing Movement Type	Curb	Yes	DWS Offset Right (in)	N/A			
115	N/A	Landing Shared	No						
	N/A	Clear Space	Yes						
	N/A	Clear Space To Crosswalk (in)	48						
\$ 531	N/A	Marked Crosswalk 1	No	N/A	Marked Crosswalk 2	Yes

Crossing 1 Direction	Е		Crossing 2 Direction	N			
HEWES_AVE		Marked Crosswalk 1 Width (in)	N/A		Marked Crosswalk 2 Width (in)	120			
StopSign	N/A	Ramp Inside Crosswalk 1	N/A	Yes	Ramp Inside Crosswalk 2	Yes			
DODGE_AVE		Crossing 1 Slope (%)	3.8		Crossing 2 Slope (%)	0.6			
StopSign		Crossing 1 Cross Slope (%)	8.0		Crossing 2 Cross Slope (%)	1.5			
	Yes	Gutter Ponding	No	Yes	Curb Slope	3.9			
	Yes	Gutter Lip Height (in)	0		Road Run Slope (%)	3.3			
_ ,	Yes	Gutter Run Slope (%)	1.6		Road Cross Slope (%)	2.2			
Data	Yes	Gutter Cross Slope (%)	0.3	Yes	Perpendicular Joint Present	Yes			
No Yes Overall Surface Condition Acceptal		eptable							
		Cross Gutter Present?	No		Spandrel Present?	No			
N/A		Replace Cross Gutter?	N/A		Replace Spandrel?	N/A			
	1

Remove & Replace Landing.

R304.2.2-Perp, R304.3.2-Para, STD 1115

531
