# Access Compliance Report Public Rights-of-Way (Curb Ramps)

Main Street: DODGE\_AVE Cross Street: HEWES\_AVE Location: NW

ADA ID: RPAT211015091116 Ramp Type: Type 1 - Perpendicular Diagonal Initial Pass/Fail: Pass Overall Compliance: No Severity Score: 4

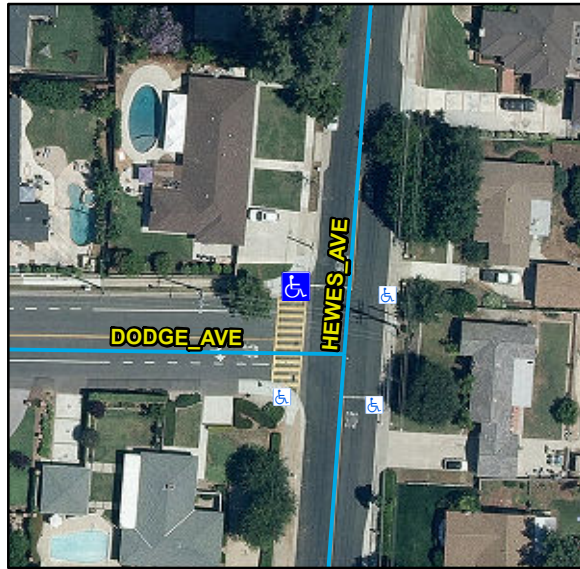
R304.2.2, R304.2.1, R304.2.2-Perp, R304.3.2-Para, STD 1115

Remove & Replace Curb Ramp With Two New Directional Ramps or Equivalent.
