# Access Compliance Report Public Rights-of-Way (Curb Ramps)

Main Street: HEWES\_AVE Cross Street: OAK\_RIDGE\_DR Location: NE

ADA ID: RPAT211015092746 Ramp Type: Type 4 - Parallel Initial Pass/Fail: Fail Overall Compliance: No Severity Score: 16

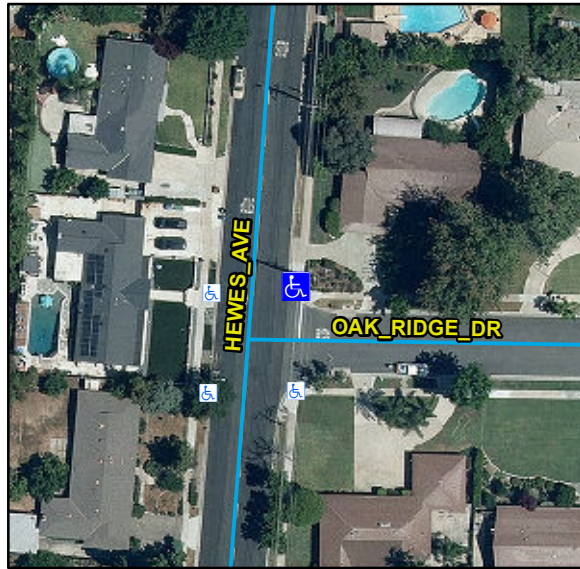
| Compliance | Description | Data | Compliance | Description | Data |
|---|---|---|---|---|---|
| No | Obstructions Present? | Yes | N/A | Utilities Present? | No |
| | Obstruction Types | Street Light | | Utility Types | |

| Compliance | Description | Data | Compliance | Description | Data |
|---|---|---|---|---|---|
| No | Ramp Run Slope LT (%) | 8.9 | Yes | Ramp Run Slope RT (%) | 5.7 |
| No | Ramp Cross Slope LT (%) | 2.5 | Yes | Ramp Cross Slope RT (%) | 0.6 |

**Remove & Replace Curb Ramp With Two New Directional Ramps or Equivalent.**

**R304.3.2, R304.5.3, R302.3, R402.2, STD 1115**

Total Cost: \$ 4000
