# Access Compliance Report Public Rights-of-Way (Curb Ramps)

Main Street: SPAULDING\_AVE Cross Street: HEWES\_AVE Location: NW

ADA ID: RPAT211015100145 Ramp Type: Type 1 - Perpendicular Diagonal Initial Pass/Fail: Fail Overall Compliance: No Severity Score: 0

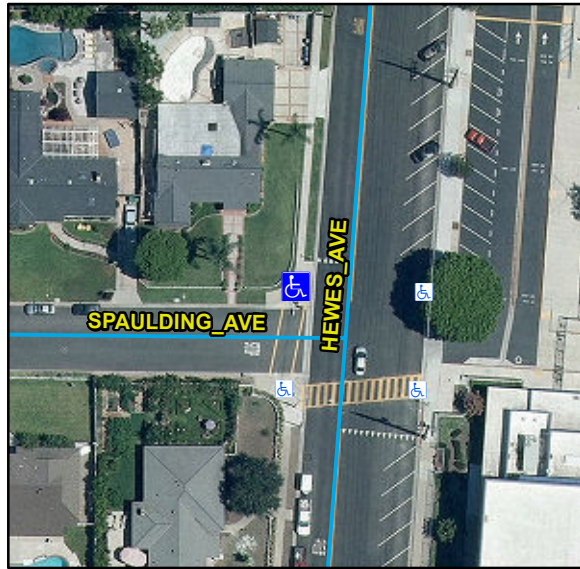
## Field Measurements/Component Compliance

**Remove & Replace Curb Ramp With Two New Directional Ramps or Equivalent.**

**R204.3, STD 1115**
